1. Report No. FAA-AM-72-15	2. Government Accession No.	3. Recipient's Catalog No.	
4. Title and Subtitle CRASH SURVIVAL ANALYSIS OF 16 AGRICULTURAL AIRCRAFT ACCIDENTS		5. Report Date April 1972

# CRASH SURVIVAL ANALYSIS OF 16 AGRICULTURAL AIRCRAFT ACCIDENTS

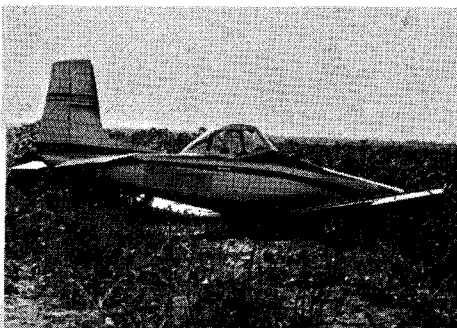
a. Side view after a minor crash of a 1968 Cessna Agwagon 188.

This Cessna Agwagon crashed in tall cotton and slid 130 feet before coming to rest (minor crash deceleration forces). The pilot was wearing his shoulder straps, lap belt and a crash helmet and they all remained in place. No injuries.

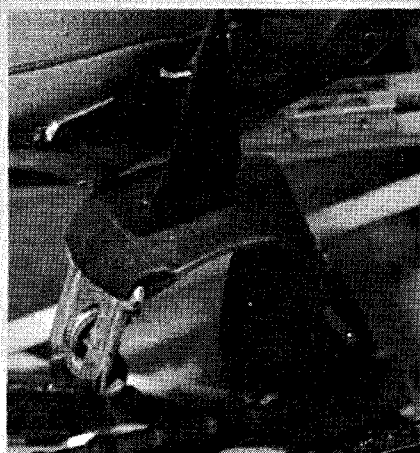
e. Even in this very minor accident the shoulder strap stitching has started to fail.

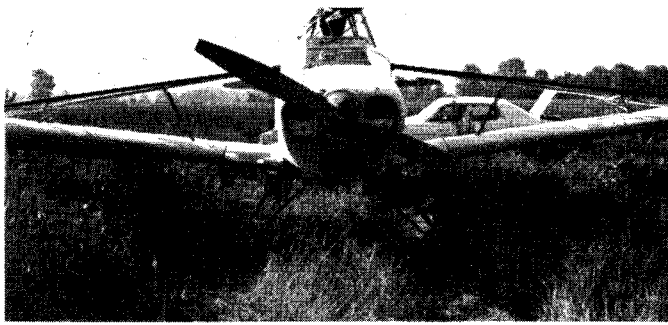
a. View of aircraft  
after being turned  
back right side up.

A 1963 Piper Pawnee (PA-25-235) was involved in a minor crash and rolled over into an inverted position. Pilot was wearing both lap belt and shoulder harness and there was no failure of this restraint equipment. Use of proper restraint and the integrity of the roll bar cage prevented any injuries in this accident.
